Residential Inspection Report

Address, Kalamazoo, MI 49008

Inspection Date:
01/15/2016

Report Number:
11516P

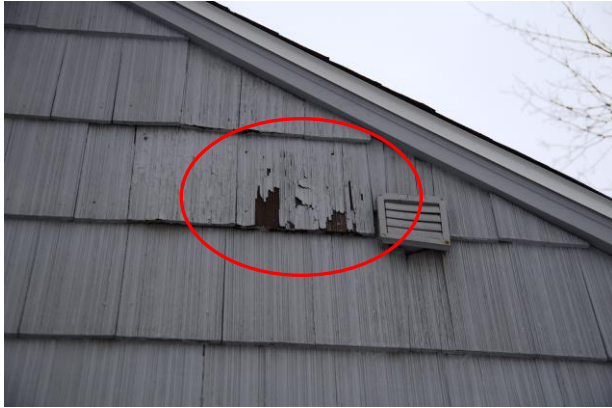
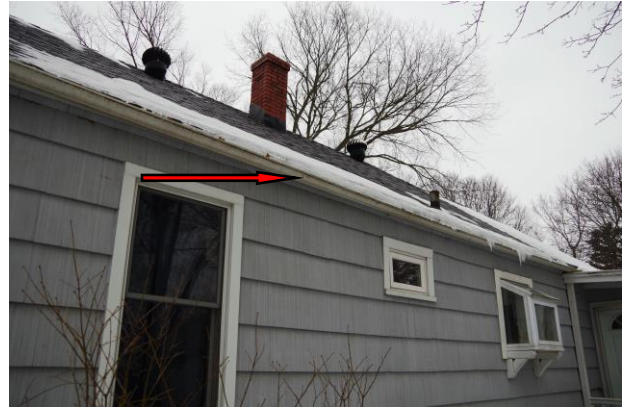
- **Improve, Repair:** A sections of the wood shingle siding on the south side of the home should be re-painted to preserve the building.
- **Monitor, Improve (As needed):** Ice was observed on the eave. This suggests that the roof may suffer from ice damming. This area should be monitored. Insulation and ventilation or other eave protection may be needed to avoid ice dam leaks.

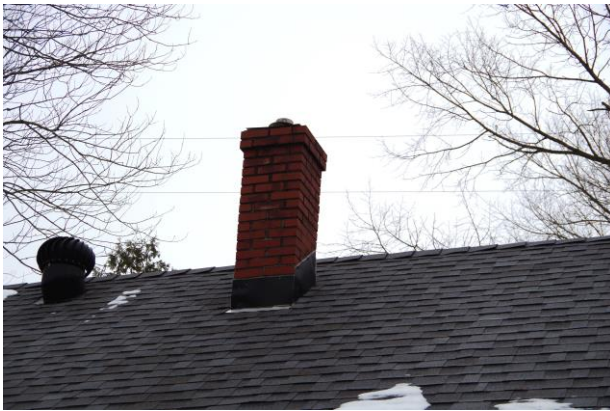
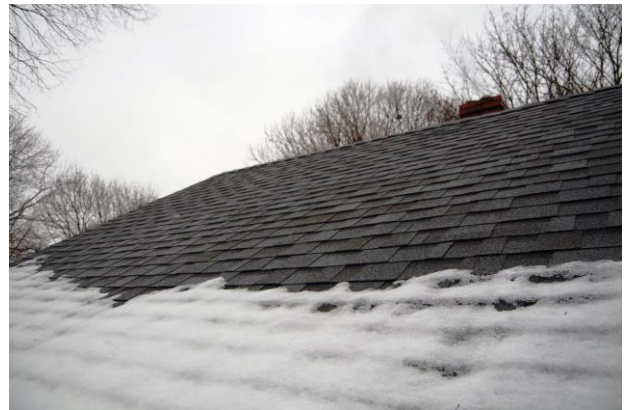
Ice damming was observed on the roof. The potential for ice dams varies with the severity of the winter and depending on insulation and ventilation under the roof. Severe ice dams can result in leaks, typically near the eaves. Solutions include better attic insulation and ventilation, eave protection below the roof coverings, or as a stop-gap measure, the installation of heating cables on the roof.

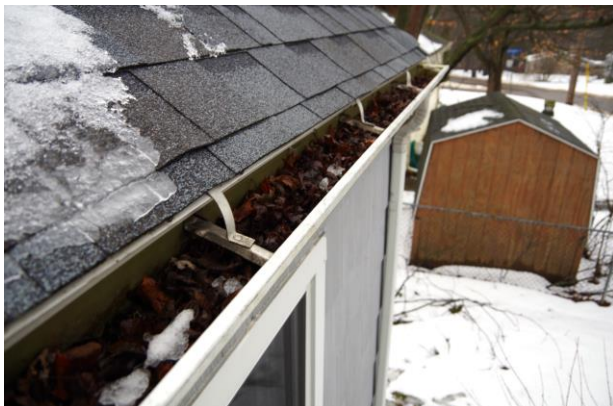
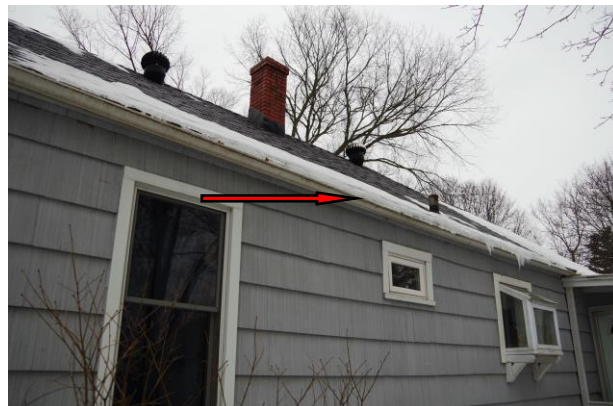
- **Improve, Repair:** The gutters require cleaning to avoid spilling roof runoff around the building – a potential source of water entry or water damage. The downspout(s) should discharge water at least five (5) feet from the house. Storm water should be encouraged to flow away from the building at the point of discharge. Loose or damaged downspouts should be repaired promptly.

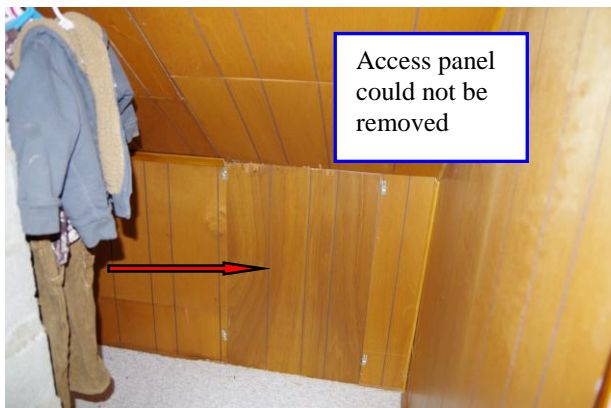
- **Improve:** We recommend access be made to the attic (and if possible to the crawlspace) followed by re-inspection.

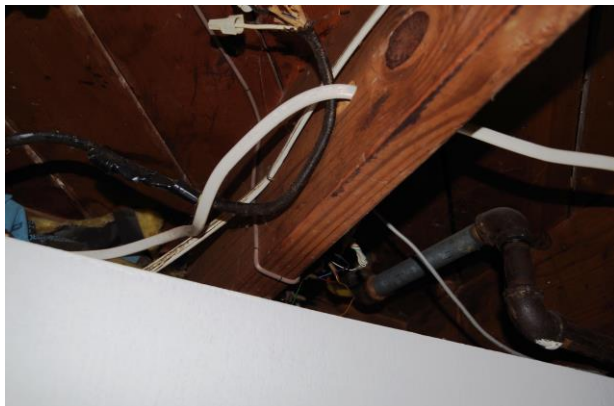
- **Repair:** Abandoned wiring in the basement should be removed or appropriately terminated with a box and cover.

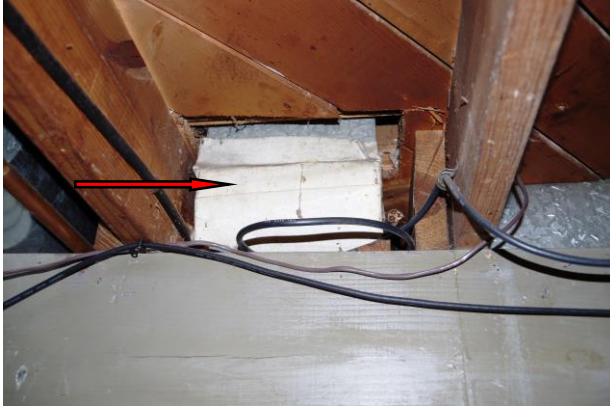
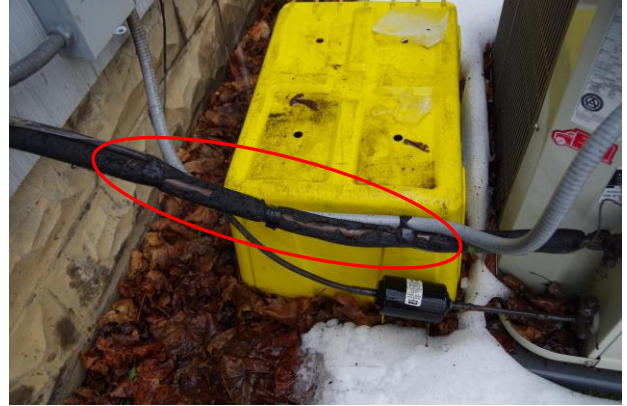
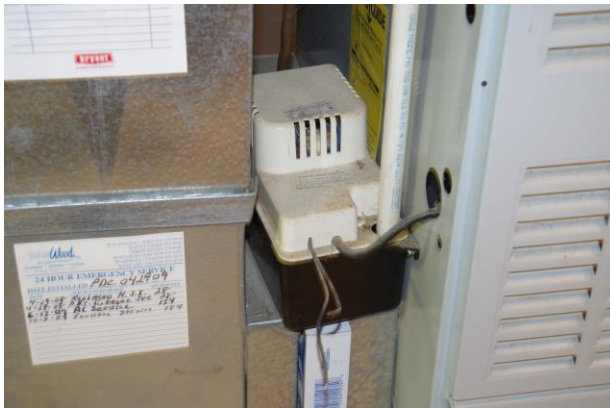
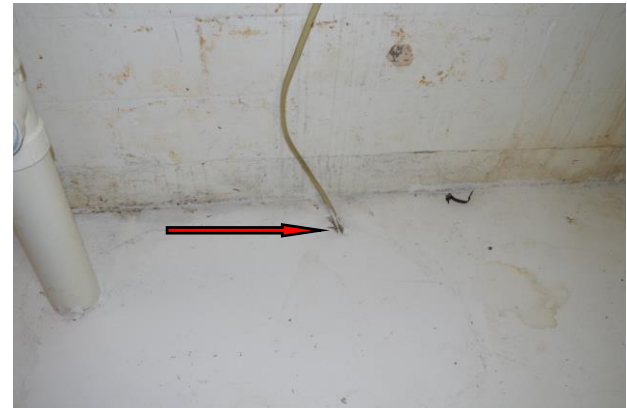
- **Repair, Safety Issue:** One or more sections of the ductwork may contain Asbestos which should be removed (Note: lab test needed to confirm). *The Environmental Protection Agency (E.P.A.) reports that asbestos represents a health hazard if "friable" (damaged, crumbling, or in any state that allows the release of fibers).* If any sections of this insulation are indeed friable, or become friable over time, a specialist should be engaged. Further guidance is available from the Environmental Protection Agency (E.P.A.). Note: There may be other materials within the home that contain asbestos but are not identified by this inspection report.

- **Repair:** Damaged and or missing insulation on refrigerant lines should be repaired. These outside lines should be insulated all the way to the compressor unit to prevent loss of temperature in the lines.
- **Improve, Repair:** The discharge location of the condensate line for the air conditioning system should be improved (i.e. improper plumbing connection).

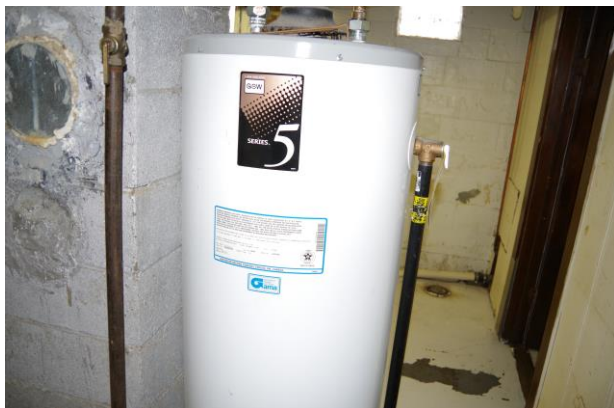
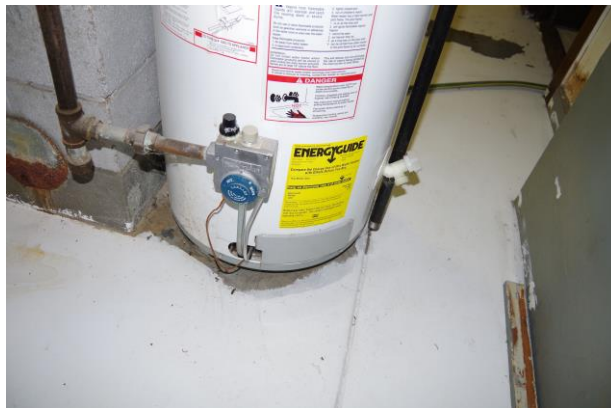
- **Deferred Cost Item:** The water heater is functional but an older unit (~17 yrs old) that may be approaching the end of its useful life. It would be wise to budget for a new unit. Water heaters have a typical life expectancy from 10 – 15 yrs.

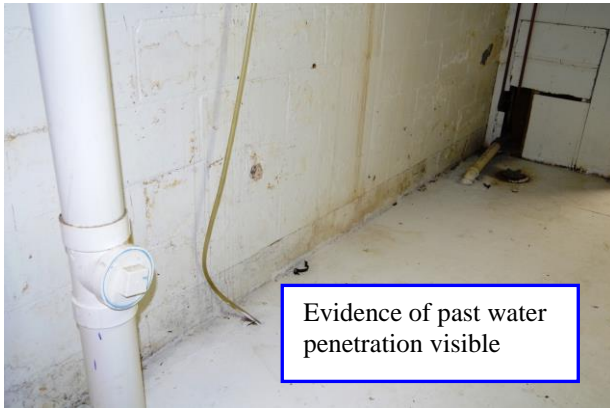
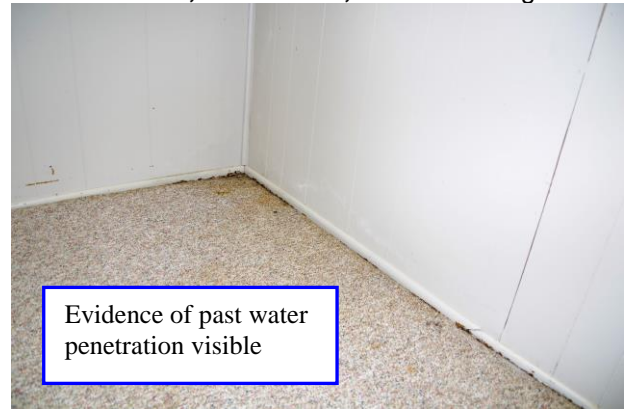
- **Monitor:** The basement shows evidence of moisture penetration. *It should be understood that it is impossible to predict the severity or frequency of moisture penetration on a one-time visit to a home.* Virtually all basements exhibit signs of moisture penetration and virtually all basements will indeed leak at some point in time. The visible evidence is not unusual for a home of this age, construction and location. Further monitoring of the foundation will be required to determine what improvements, if any, will be required. Basement leakage rarely affects the structural integrity of a home.

In the event that basement leakage problems are experienced, lot and roof drainage improvements should be undertaken as a first step. Please beware of contractors who recommend expensive solutions. Excavation, damp-proofing and/or the installation of drainage tiles should be a last resort. In some cases, however, it is necessary. Your plans for using the basement may also influence the approach taken to curing any dampness that is experienced.

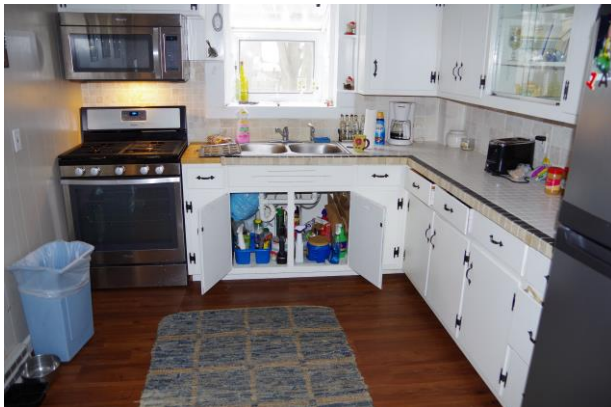
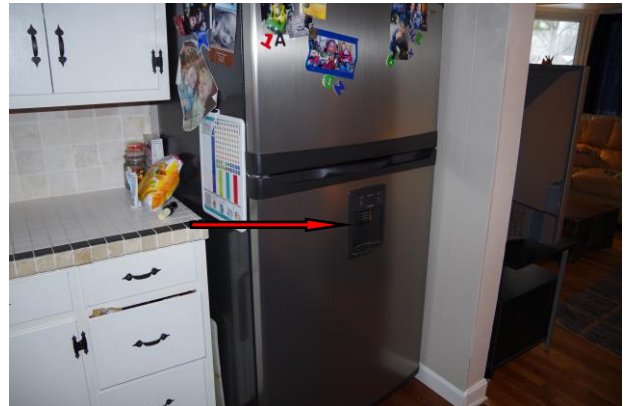
- **Repair:** The refrigerator water dispenser (in door) is inoperative.

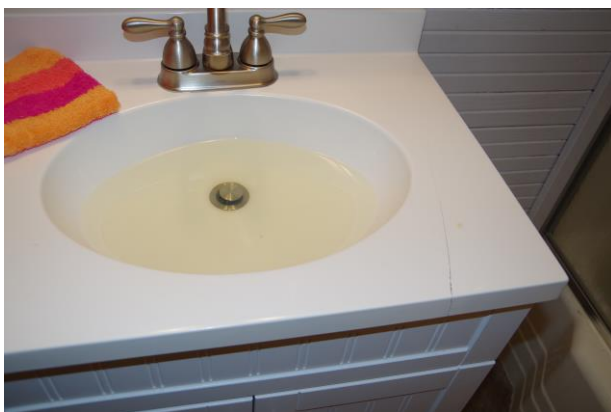
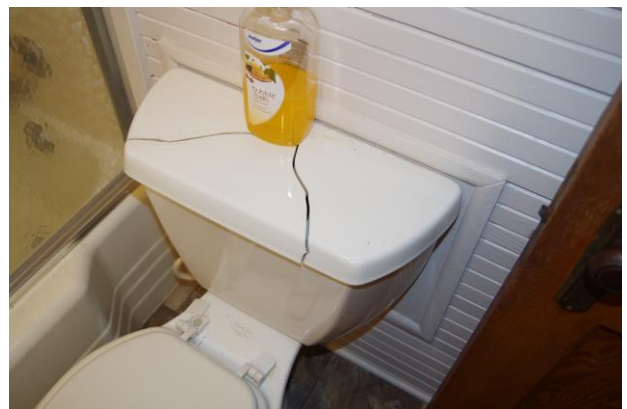
- **Repair:** The toilet tank lid is cracked (in the hallway bath) and should, ideally, be replaced.
- **Improve:** The sink is not properly draining in the hallway bathroom suggesting there is some blockage in the drain piping (e.g. trap).
