Residential Inspection Report

Address, Kalamazoo, MI 49008

Inspection Date:
01/15/2016

Report Number:
11516P

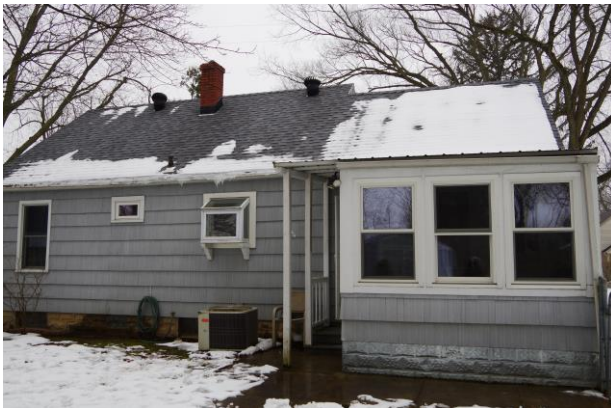
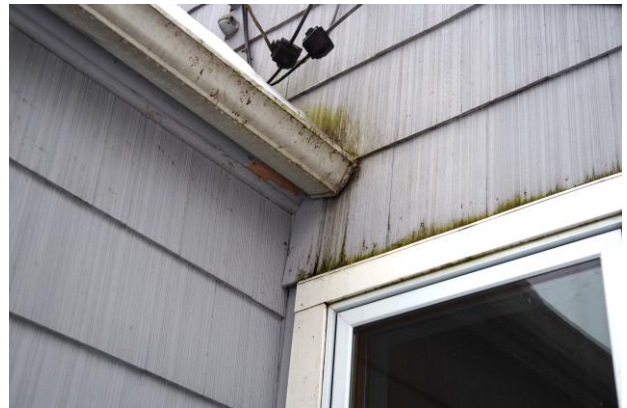
The exterior of the home shows normal wear and tear for a home of this age; however a few areas of the home have lacked some maintenance; repairs and/or improvements are recommended.

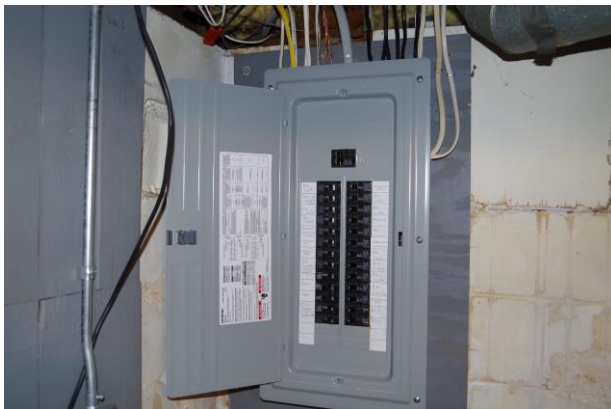
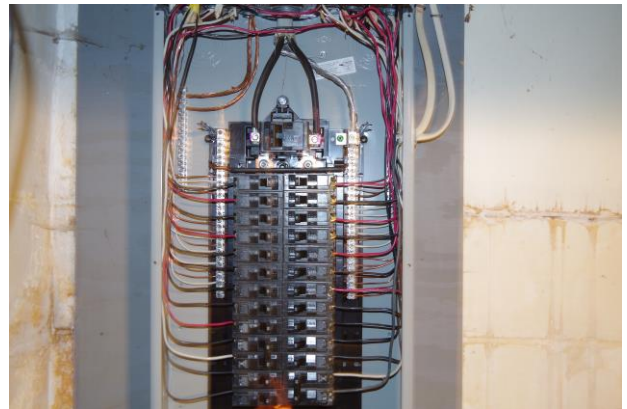
Inspection of the electrical system revealed the need for typical, minor repairs. Although these are not costly to repair, they should be high priority for safety reasons. *Unsafe electrical conditions represent a shock hazard.* A licensed electrician should be consulted to undertake the repairs recommended below.

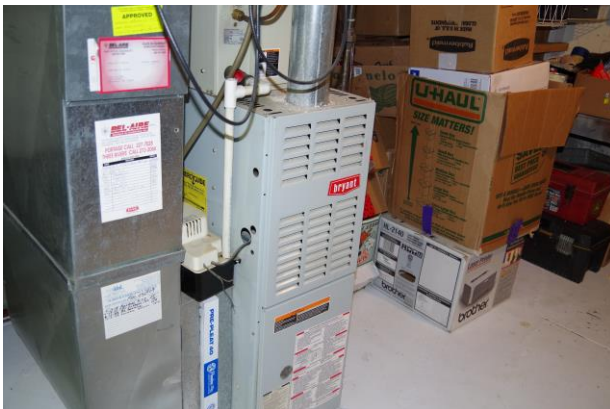
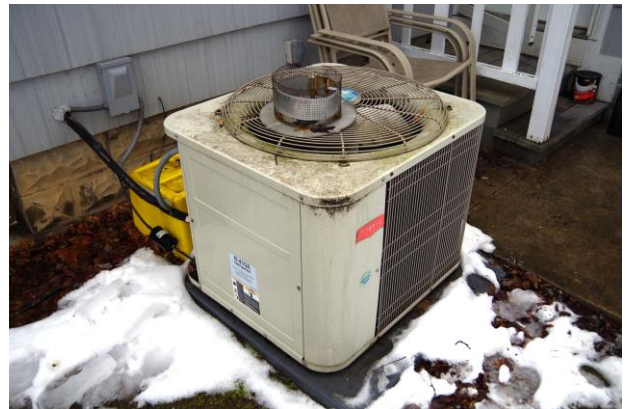
The heating system is functional and shows no visible evidence of major defects; however repairs to the ductwork are highly recommended. The air filter is relatively clean. The air conditioning system could not be tested at this time of the year (due to low outside air temperature); however improvements to the system are recommended.

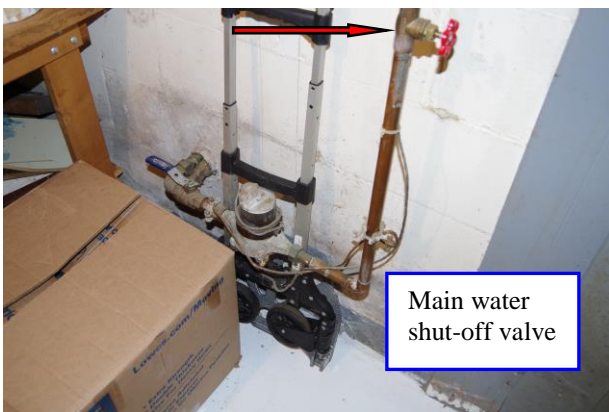
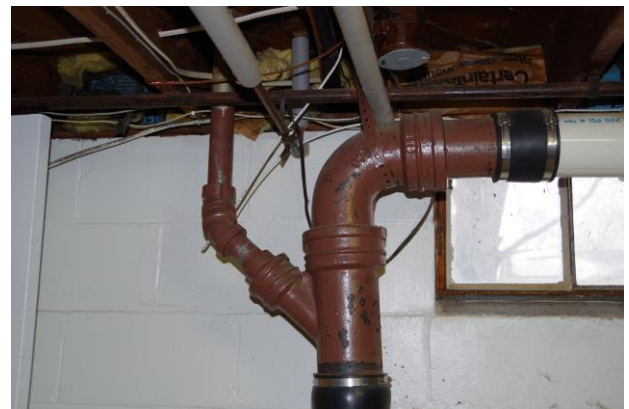
The plumbing system is functional but some of the components are older and may need to be replaced in the near term. Upgrading older components would be a logical long term improvement. In the interim, a higher level of maintenance will likely be required.

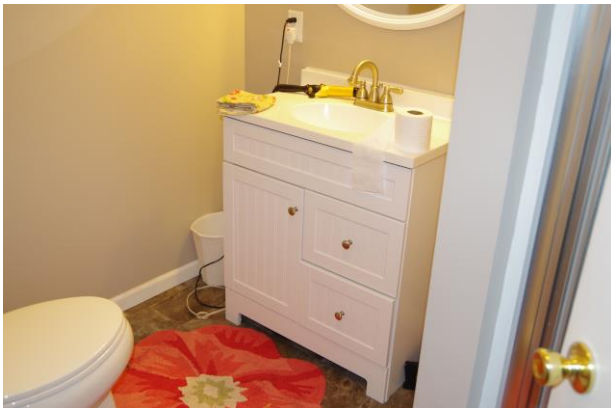
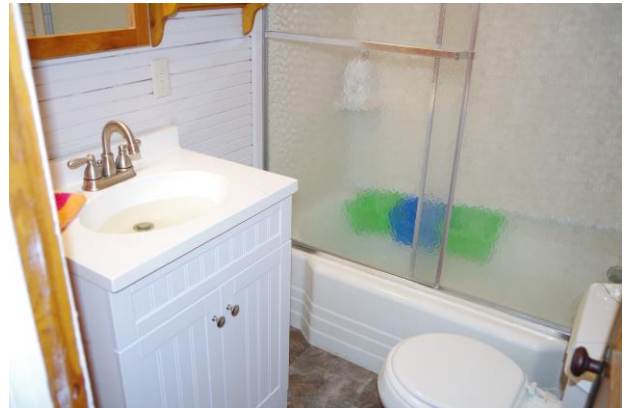
The hallway bathroom has some typical minor flaws and some additional damaged fixtures.
